# Evaluation Report 300

## Krone KR180 Baler

## KRONE KR180 BALER

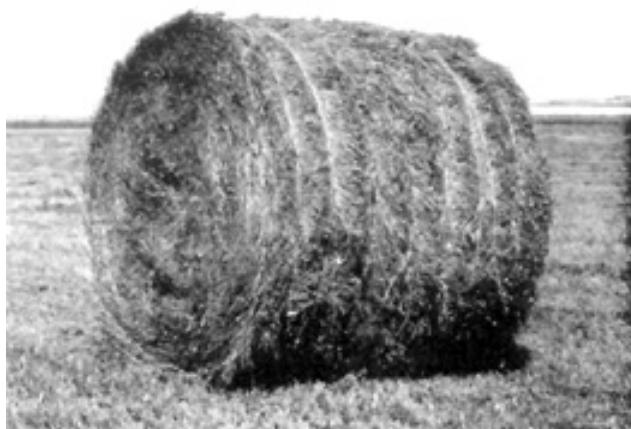
**Bale Quality:** The Krone KR180 produced firm, durable bales with flat ends and uniform diameter in most crops (FIGURE 2). Bales were of very good quality when baled in well formed windrows at the optimum moisture content. However, in light, dry conditions, irrespective of crop and in unconditioned

FIGURE 2. Typical Hay Bale.

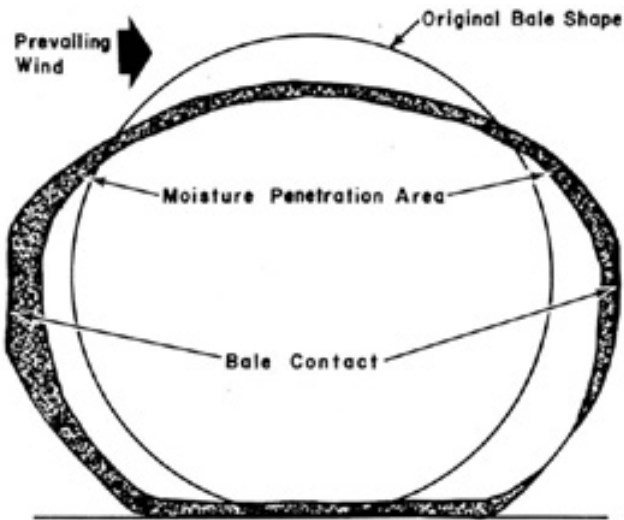
**Bale Weathering:** A common practice in the prairie provinces is to store round bales outside. Bales were closely stacked in rows, situated in a level area, with one side exposed to the prevailing winds. Bales were subjected to about 4.5 in (115 mm) of rain and above average wind conditions over a period of about 170 days. FIGURE 4 shows the condition of a typical Krone KR180 hay bale (alfalfa and bromegrass mixture) after 170 days of weathering. The condition of the weathered bales was good. Moisture had penetrated to a maximum of 5 in (127 mm) on the windward side in the area where another bale was touching. Spoilage occurred to a depth of about 1.5 in (40 mm) in the ground contact area and where other bales touched the sides.

FIGURE 4. A Typical Hay Bale After 170 Days of Weathering.

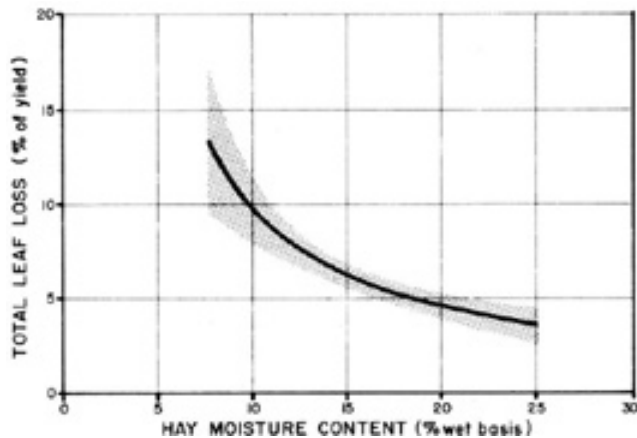
FIGURE 5 shows the importance of baling at higher moisture contents. This figure represents an accumulation of data for several round balers showing the total measured leaf loss over a range of hay moisture contents, in fields of mixed alfalfa, crested wheatgrass and bromegrass. Although the Krone KR180 was tested in a different crop, its performance was within the range presented in the figure with the exception of slightly lower losses at higher moisture contents.

FIGURE 5 represents nearly ideal baling conditions with relatively heavy windrows which had been conditioned to enhance drying of the hay stems. Much higher leaf loss can be expected in light, unconditioned windrows. While feedrate did not appreciably affect losses in the ideal conditions shown in FIGURE 5, loss tests in light unconditioned windrows have shown that round baler losses can be reduced by keeping the feedrate as high as possible to minimize time in the baling chamber. Bale chamber losses in light crops can also be reduced by running the tractor at a lower power take-off speed to reduce the number of turns needed to form a bale.

FIGURE 5. Leaf Loss in Mixed Alfalfa, Crested Wheatgrass and Bromegrass.

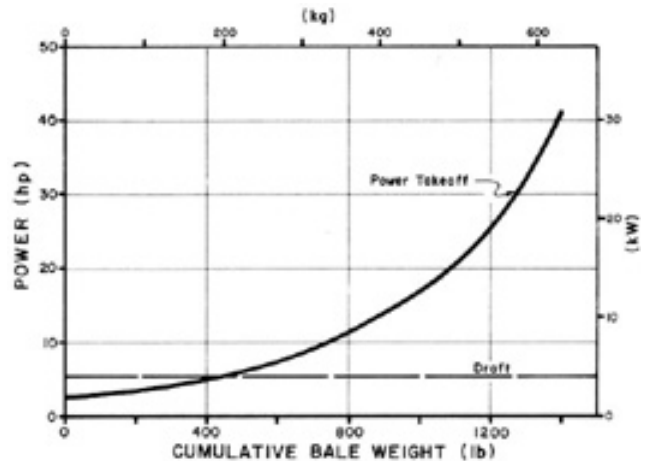
**Power Requirements:** FIGURE 6 shows the power take-off and drawbar input for the Krone KR180. The power input is

plotted against bale weight to show the power requirements while a bale is formed. Power take-off input varied from 2.7 hp (2 kW) at no load to a maximum of 42 hp (31 kW). Drawbar requirements at 6.8 mph (11 km/h) on flat firm fields were about 5.5 hp (4 kW). Although maximum power requirements did not exceed 48 hp (36 kW), additional power was needed to suit field conditions. In soft, hilly fields a 65 hp (49 kW) tractor would be needed to fully utilize baler capacity.

FIGURE 6. Power Consumption During Bale Formation in Alfalfa Bromegrass.

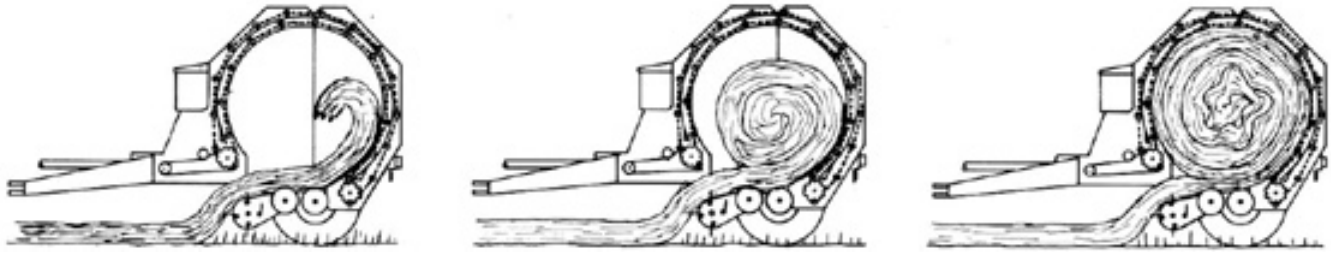
**Forming a Bale:** It was easy to form a neat, durable bale in most crops. Feeding hay across the entire width of the bale chamber during bale core formation was not critical as the hay tumbled within the bale chamber, distributing itself quite evenly across the chamber. Alternate side to side feeding was required during the later stages of bale formation to produce bales of uniform diameter. FIGURE 7 shows stages of bale formation in the Krone KR180.

**FIGURE 7.** Stages of Bale Formation: (Left) Starting Bale, (Centre) Partially Completed Bale, (Right) Completed Bale.
